Rule 26 Report

This report is for the residents at 16207 E. 47th Place, Tulsa, OK 74134. I have prepared a replacement cost estimate for the roof and exterior of this home. I was also asked to review the existing documentation and other written reports that addressed this home and provide my opinions on them.

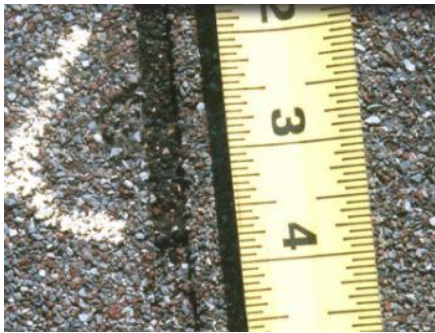
Hail damage on a laminated composition shingle roof surface is identified by bruising, chipping, punctures, or fractures of the laminated composition shingle. This is usually seen by round bruises on a laminated composition shingle. Below are photographs of laminated composition shingles identified by HAAG as damaged by hail:

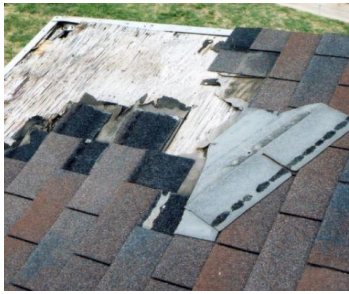
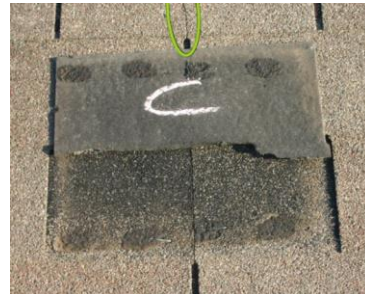
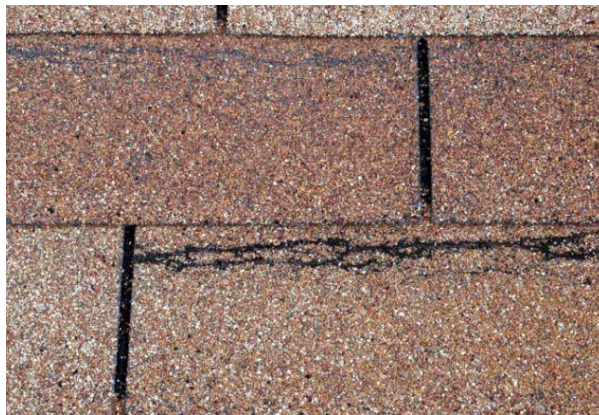
Wind damage on a laminated composition shingle roof surface is identified by missing shingles, lifted shingles, creased shingles, or torn laminated composition shingles. During a windstorm, wind speeds will vary from different directions and can cause more severe damage to different slopes of the roof. Below are photographs of laminated composition shingles identified by HAAG as damaged by wind:
